**ASSESSMENT OF GRAVEL OPERATION DAMAGE TO
PREHISTORIC SITES AND RECORDING THE SANTA FE
TRAIL WITHIN THE JOHN MARTIN RESERVOIR
PROJECT AREA, BENT COUNTY, COLORADO**

**EVALUATION OF OLD LAS ANIMAS
(5BN176), A LATE NINETEENTH CENTURY
TOWN ON THE ARKANSAS RIVER,
BENT COUNTY, COLORADO**

**Prepared for
U.S.Army Corps of Engineers
Albuquerque District
New Mexico**

1987

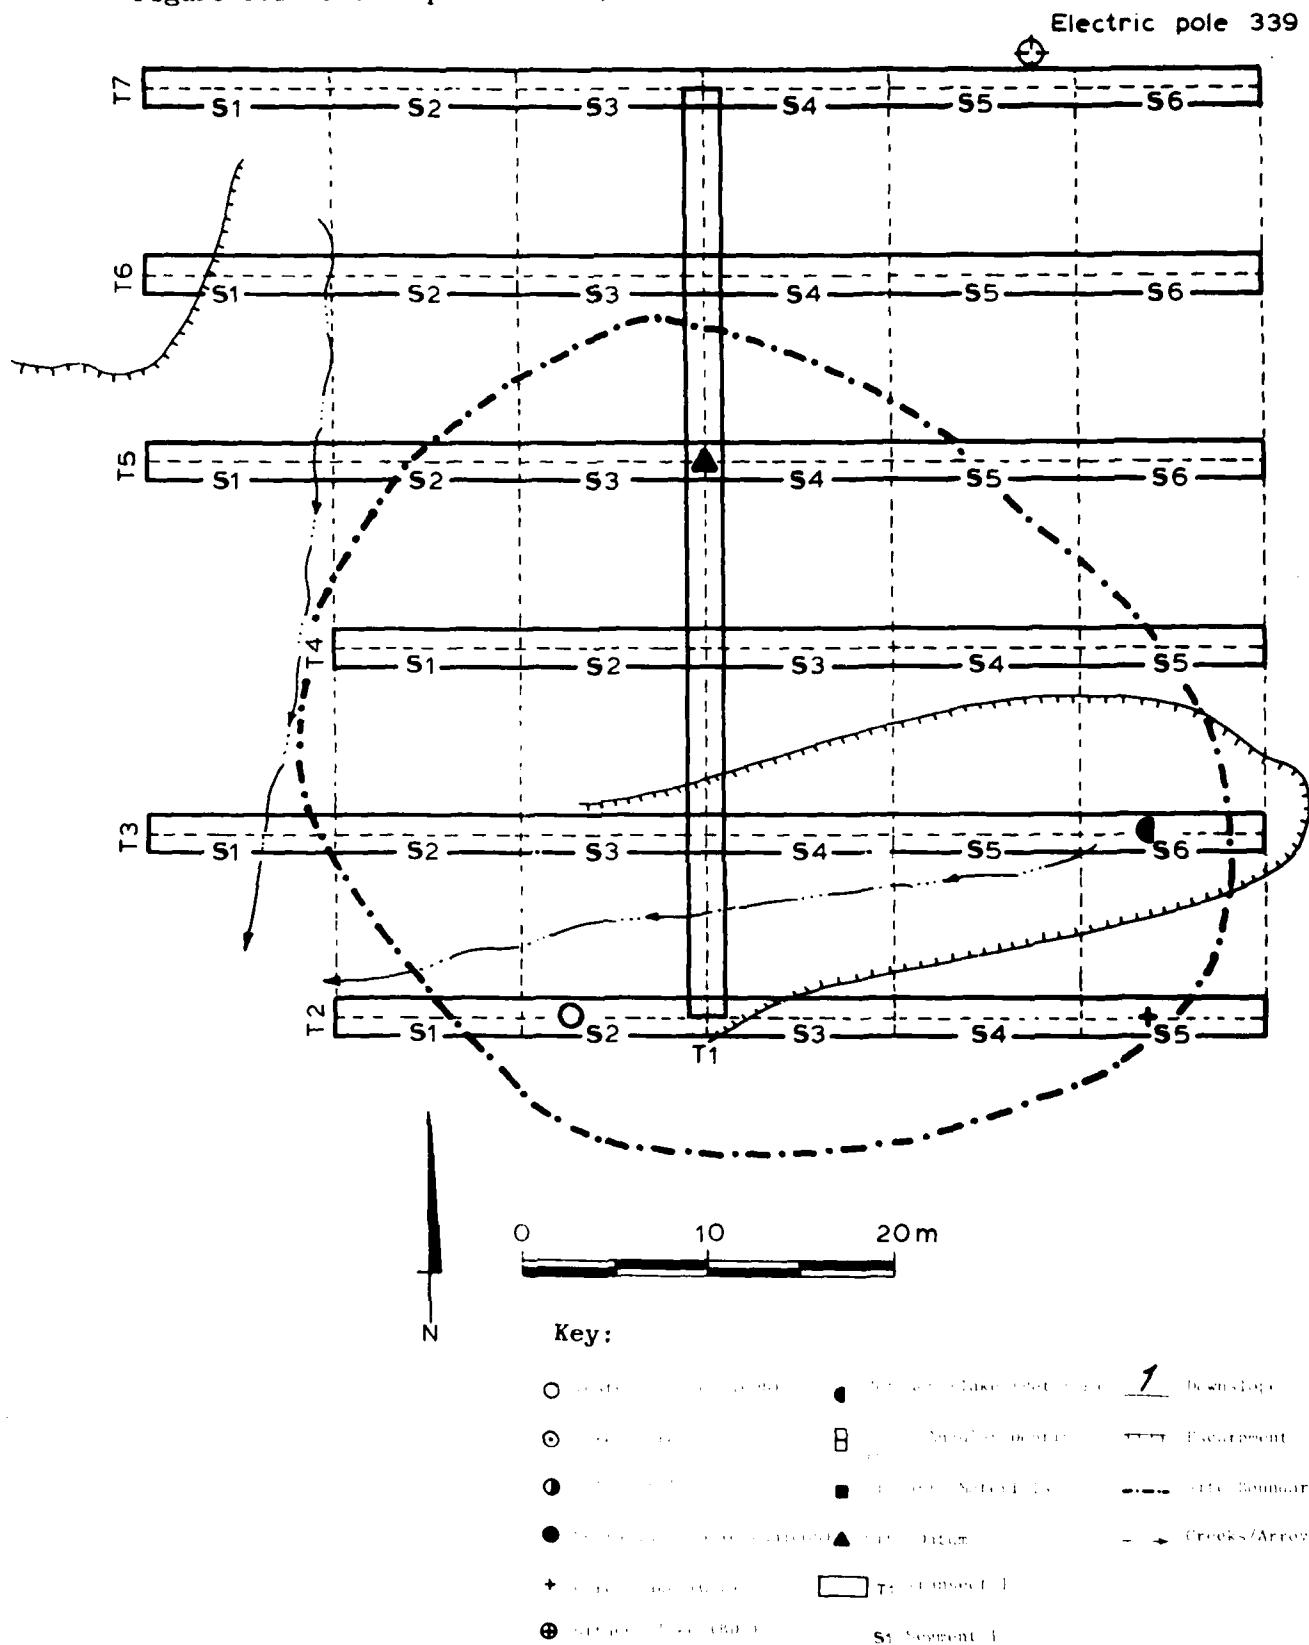
Figure 3.1 Site Map of 5BN198, John Martin Reservoir.

The site has not been impacted by gravel quarry operations.

This lithic scatter has limited research potential. It has an estimated tool density of 0.009 items per square meter and the assemblage shows limited diversity. No further research is recommended.

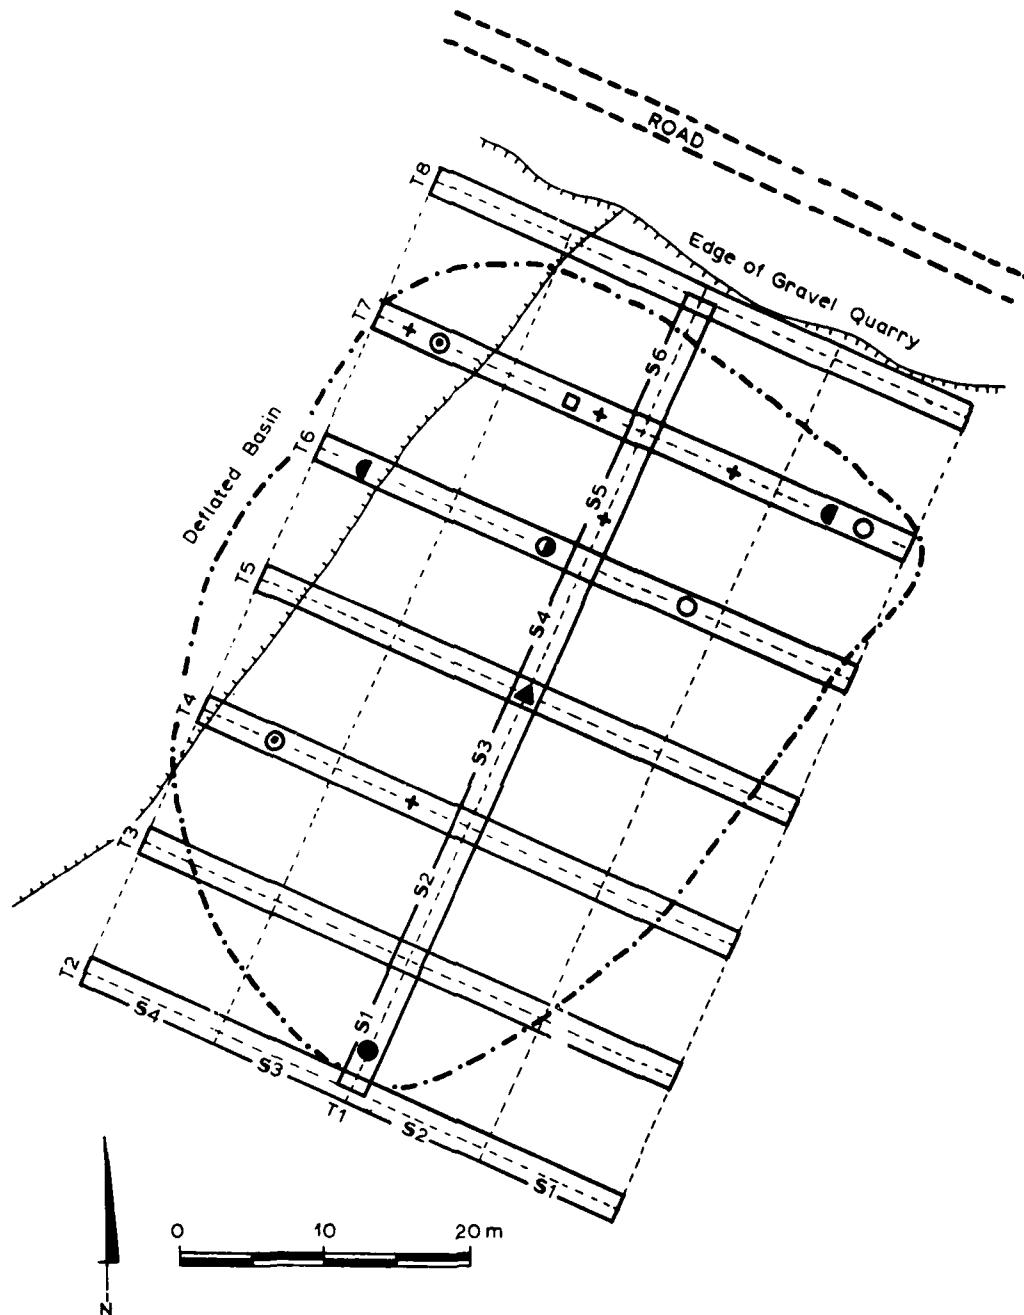
Figure 3.2 Site Map of 5BN199, John Martin Reservoir.

Recent quarry operations have removed an unknown amount from the north-northeast end of the site. The extent of gravel pit impact on site 5BN199 can not be determined since the SAI site datum was not found.

This lithic scatter has limited research potential. It has an estimated artifact density of 0.056 items per square meter and displays limited diversity in the tool assemblage. No additional cultural resource work is recommended.

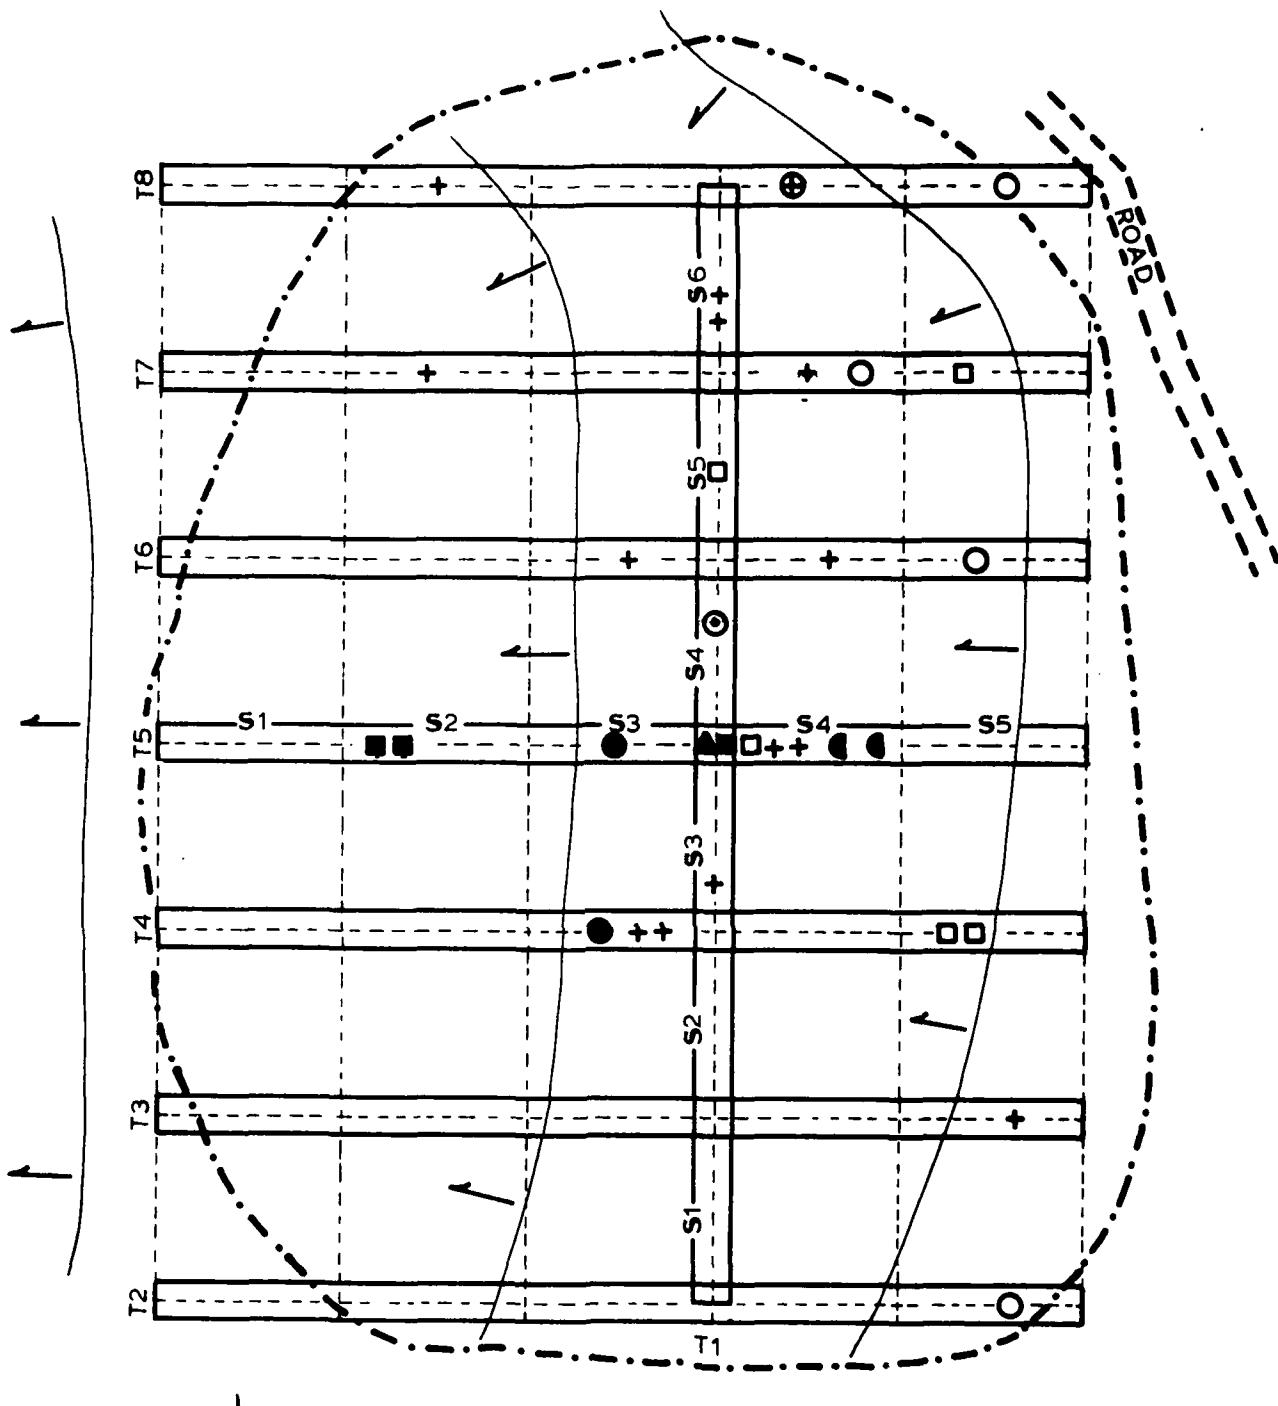
Figure 3.3 Site Map of 5BN200, John Martin Reservoir.

No recent quarrying impacts have affected the site. The early road possibly associated with quarrying activities may have caused some damage to the east edge of the site.

This lithic scatter has limited research potential. The site has an estimated artifact density of 0.122 prehistoric and historic artifacts per square meter area, and the variability of the tool assemblage is limited. The historic materials may date to several periods during the late nineteenth century and early twentieth century. Some materials could date to the latter periods of Santa Fe Trail usage, but most post-date this period. This later material may relate to a trash scatter associated with or following the early quarrying activities. No further work is recommended for this site.
